West Basin Facility Plan Project 7054

PART 3 - TECHNICAL MEMORANDUM 9

Conveyance – Seismic Resiliency

FINAL / October 2025

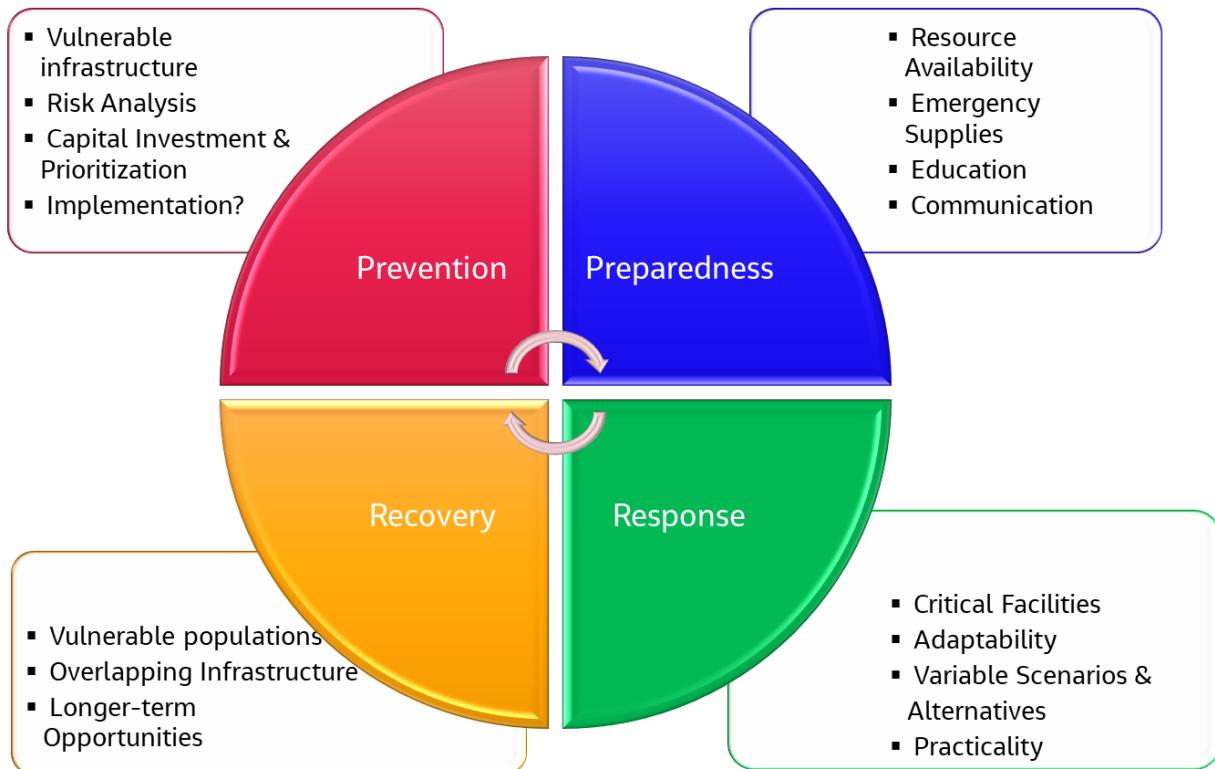
Figure 9.1 Perspectives on Seismic Resiliency Planning

Typical planning for seismic resiliency can be viewed from four perspectives as described below and shown in Figure 9.1.

- Prevention: Efforts to minimize impacts to infrastructure during a seismic event.
 - » Vulnerability assessments based on infrastructure location and design.
 - » Capital investment to reduce risk including strengthening vulnerable assets.
- Preparedness: Storing commodities, materials, and planning for work immediately following a seismic event.
 - » Plans for resources (temporary sanitation) and short-term options to bring infrastructure back online.
 - » Public education and communication.
 - » Equity considerations for vulnerable communities.

- Responsiveness: Work to bring basic and critical facilities back online.
 - » Adaptability considerations (variable scenarios and alternative plans).
 - » Critical services first (hospitals and other dedicated gathering places).
 - » Practicality of solutions including definition of short term and longer-term objectives.
- Recovery: Longer-term efforts to replace and rebuild infrastructure.
 - » Consider priorities by total population served, vulnerable populations, critical service restoration for secondary services (critical businesses, schools, etc).
 - » Align replacement with longer-term opportunities to improve operations, capacity, materials or other targeted efficiencies for improved infrastructure life cycle and resiliency.

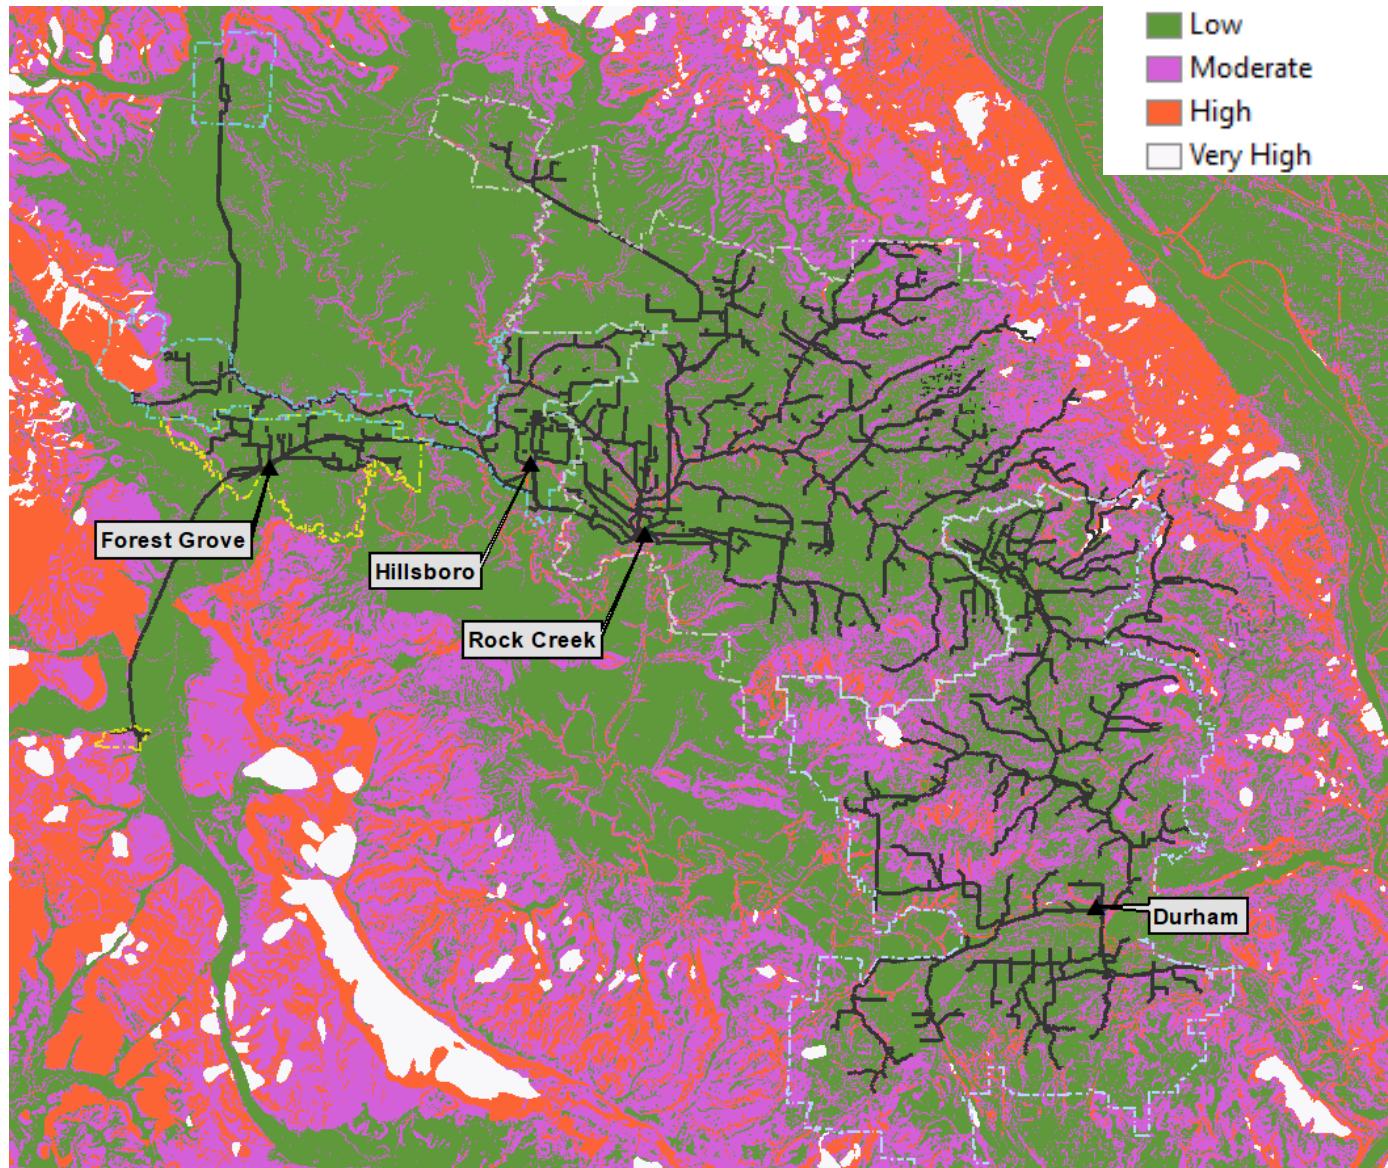
Figure 9.2 Landslide Susceptibility (DOGAMI mapping) and District Sewer Infrastructure

The Oregon Department of Geology and Mineral (DOGAMI) produces risk mapping for the state of Oregon showing areas of low to high landslide susceptibility and low to high liquefaction probability. Landslides and liquefaction may be introduced in high-risk areas during a seismic event. Figures 9.2 and 9.3 show the DOGAMI risk mapping related to the District sanitary sewer infrastructure for landslide susceptibility and liquefaction probability respectively.

Landslide susceptibility is a moderate risk for sanitary sewer infrastructure in Washington County within or adjacent to creek beds. Landslides can leave shallow pipelines exposed and vulnerable to damage including falling debris.

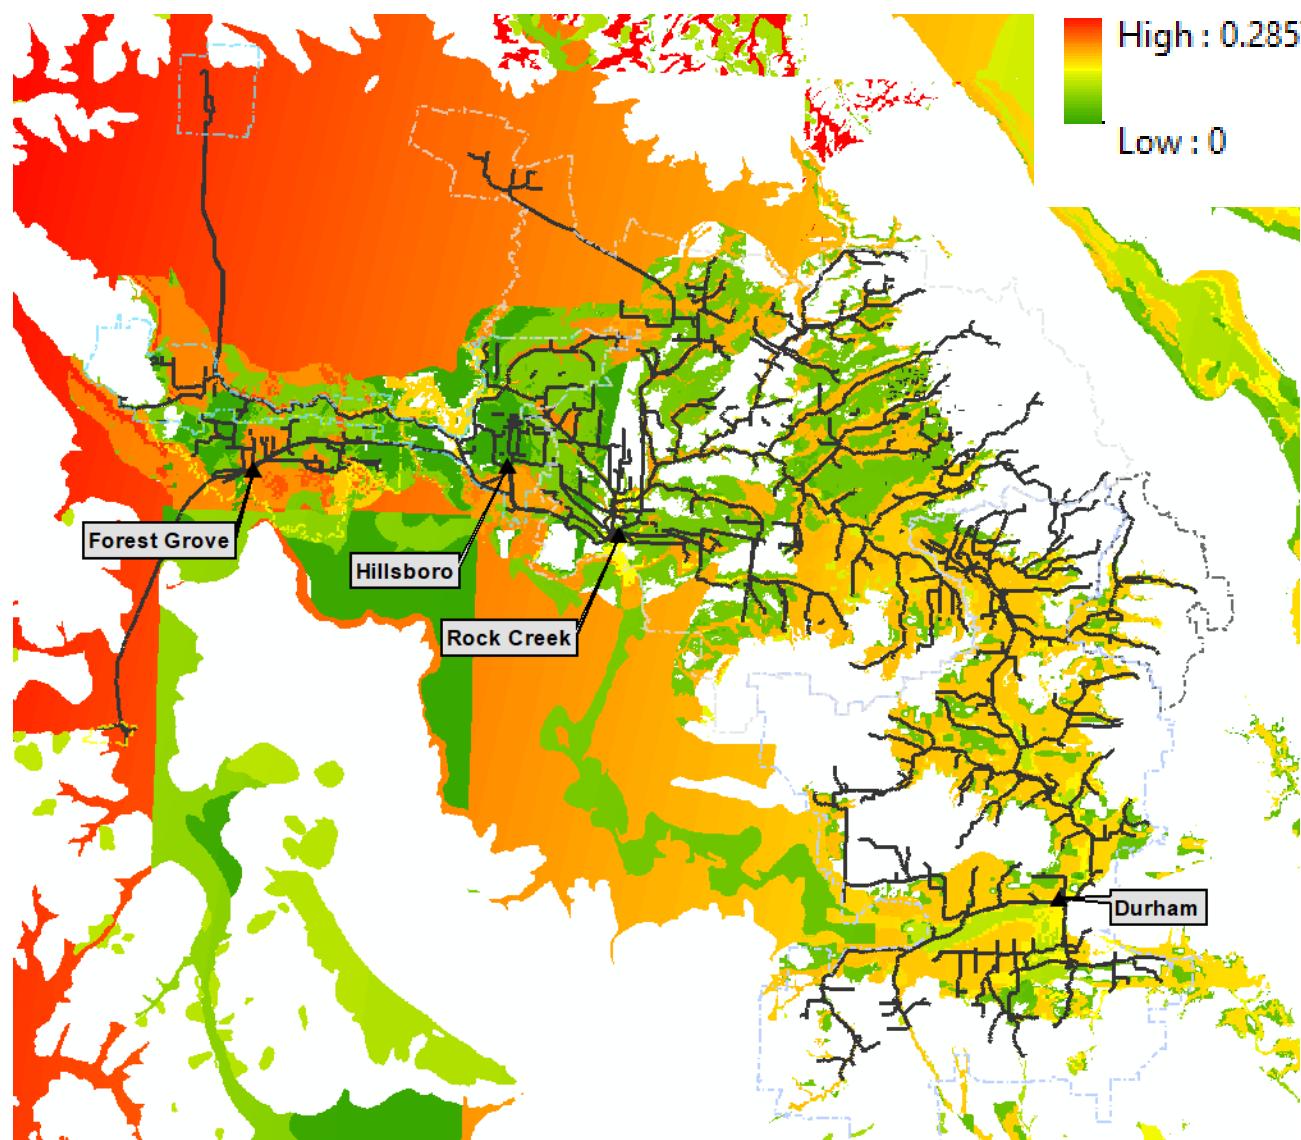
Figure 9.3 Liquefaction Probability (DOGAMI mapping) and District Sewer Infrastructure

Liquefaction probability is a moderate to high risk for sanitary sewer infrastructure in Washington County. When soil becomes liquefied during an earthquake, it can behave as a liquid causing lateral movement and infrastructure displacement including pipe rupture. This is of particular concern for pipe bridges where the bridge structure and pipeline may experience movement during a seismic event. There are vulnerable areas particularly near the Hillsboro WRRF (adjacent to wetlands), west Forest Grove (due to soils and topography), and adjacent to the Forest Grove WRRF. The cities of Banks, Gaston, and North Plains are also at higher risk due to topography and soil conditions.

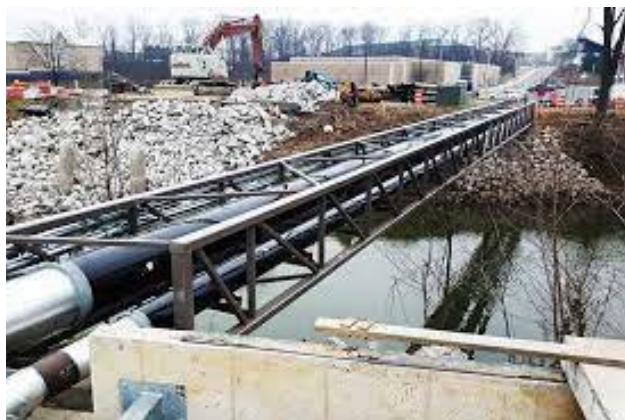
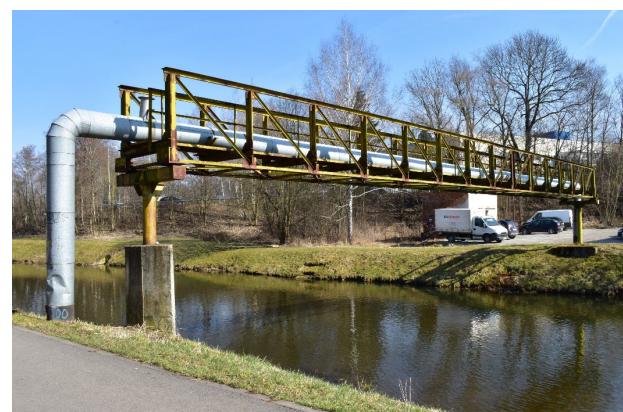
Figure 9.4 Above Ground Pipe Bridge (Bridge Support Pipeline Only)

- Above ground pipe bridges (see Figure 9.4).
 - » Type of bridge (beam, suspension, cable, rack)
 - » Floating (uncommon)
 - » Pipe support (clamps, saddles, hangers, blocks, rack)

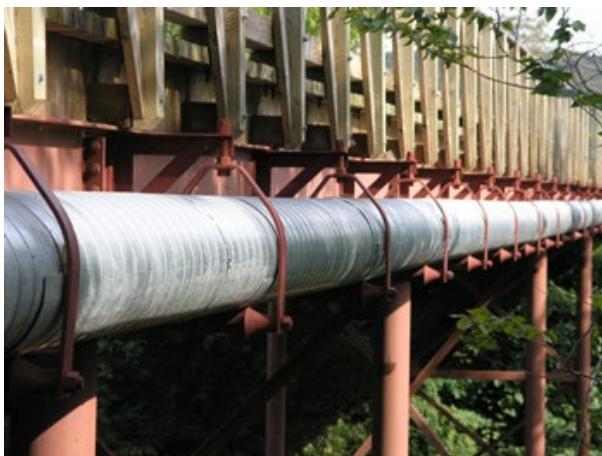
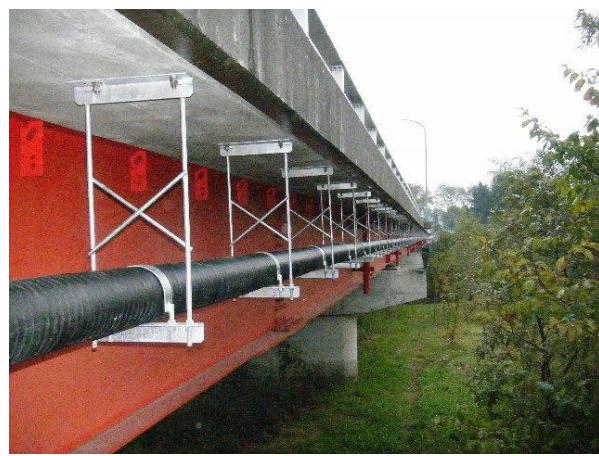
Figure 9.5 Pipeline Attached to a Vehicle or Pedestrian Bridge

- Pipe attached to pedestrian or vehicle bridge (see Figure 9.5).
 - » Type of bridge (beam, suspension, cable, truss)
 - » Bridge characterization (vehicle, pedestrian)
 - » Pipe support (clamps, saddles, hangers, blocks)

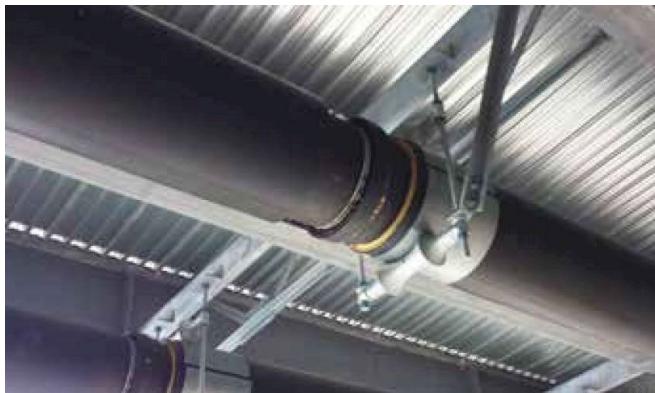
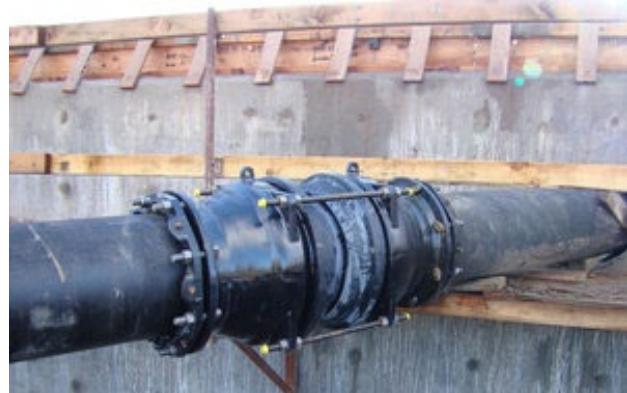
Figure 9.6 Mitigation and Prevention (left = anchoring to prevent lateral shifts; right = flexible joint to allow movement without rupturing pipe)

Mitigation and prevention for potential damage of pipe bridges includes the following (see Figure 9.6):

- Improve bridge supports, materials, and foundations.
- Add flexible joints and connections for pipelines.
- Add appropriate anchoring and restraints (prevents lateral shifts).

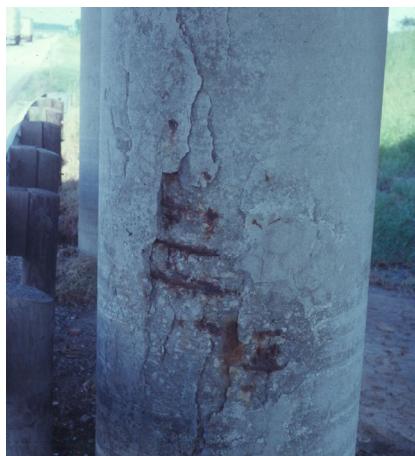
Figure 9.7 Bridge Damage (exposed rebar/spalling)

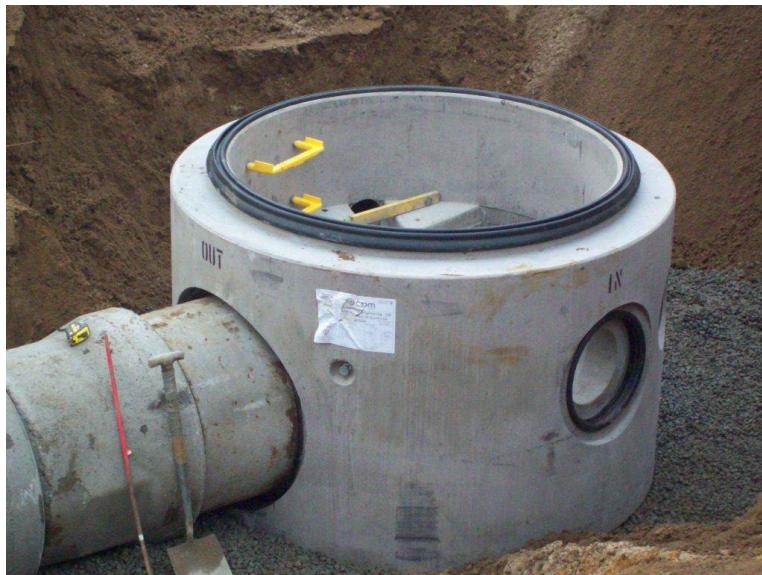
Figure 9.8 Flexible Pipe Connection Manhole

- Interceptors or trunk lines (backbone to system, consider resilience for new trunk lines)
 - » Jointless and seamless pipeline segments (avoid points of weakness in the pipeline).
 - » High-Density-Polyethylene (HDPE) pipe materials (greater structural integrity and flexibility to withstand ground motion, fused joints).
 - » For rehabilitation, Cured-in-Place Pipe (CIPP) has been tested to withstand ground motion and maintain structural integrity.
- Manhole floatation (anchors or bracing)
- Flexible pipe connection manhole (see Figure 9.8)
